## Introduction

## Test Setup

## Objective

To investigate the effects of reinforcement detailing and loading history on the capacity and the failure modes of confined boundary elements of RC rectangular walls.

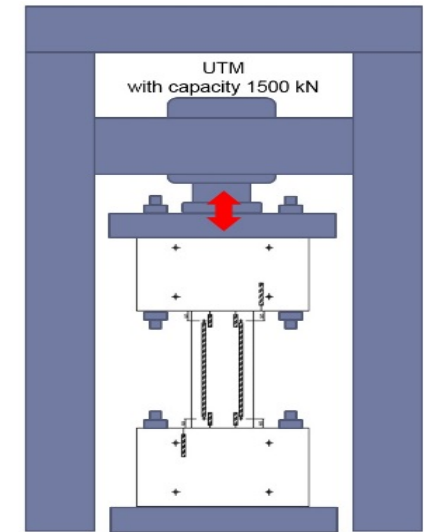
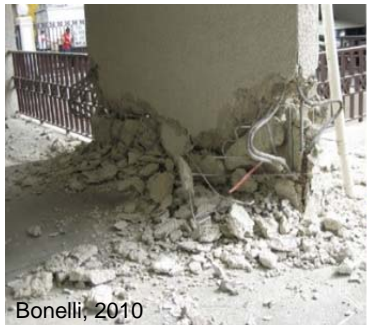
**Spec. 5B-C:**  
 $P_{max} = -1121 \text{ kN}$ ,  $\epsilon_{max} = -0.40\%$   
**Spec. 5B-M:**  
 $P_{max} = -1045 \text{ kN}$ ,  $\epsilon_{max} = -0.38\%$

Both 5B-C and 5B-M elements failed by buckling of longitudinal reinforcement, followed by crushing of concrete in buckling region.

The lack of closely spaced transverse reinforcement failed due to buckling of longitudinal reinforcement otherwise the dense confinement improved the performance of element where maximum capacity and ductility increased. Therefore, a limit for both transverse reinforcement and ties spacing should be considered to provide sufficient confinement.

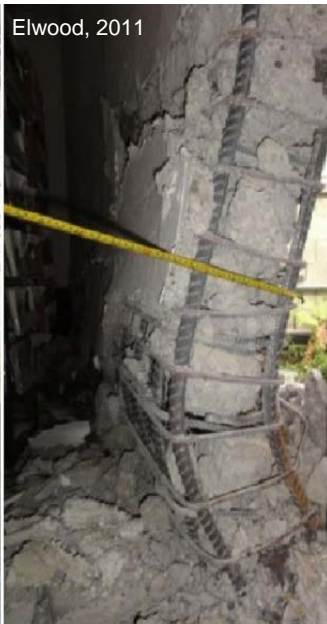
**Spec. 6B-C:**  
 $P_{max} = -1175 \text{ kN}$ ,  $\epsilon_{max} = -1.47\%$   
**Spec. 6B-M:**  
 $P_{max} = -1237 \text{ kN}$ ,  $\epsilon_{max} = -1.58\%$

Both 6B-C and 6B-M elements failed by crushing of compressive concrete followed by localized buckling of the damaged region.
